Access Conwall

Report on a visit to Bridleway 21 in Cardinham—Cabilla Manor

This report has been prepared in light of our recent visit (September 2012) to inspect the bridleway after renovations done earlier in the year by Cornwall Council.

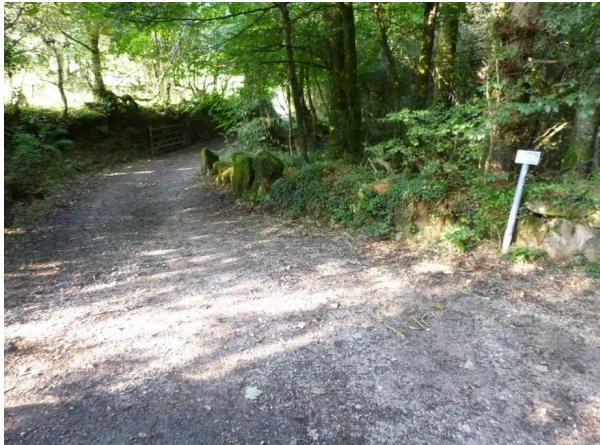
We started our visit at the southern end (pictured left) where it starts as an unmade vehicular track which serves a local property.

The track is in reasonable condition with compacted small gravel on firm base.

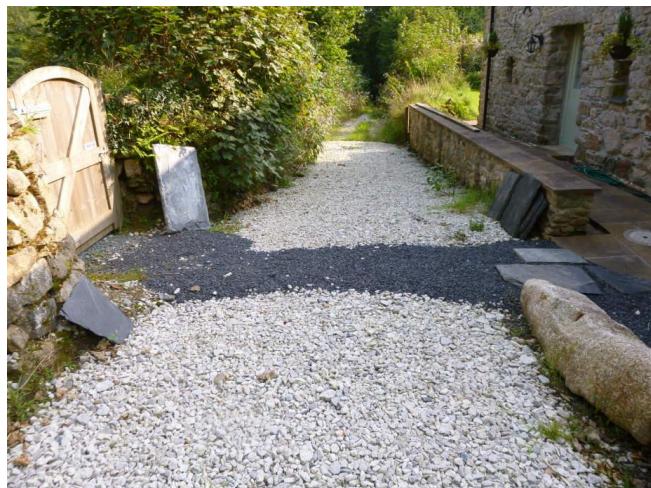
All sections of the track that have been renovated are surfaced in a coarse and sharp aggregate that should only be used for foundation or drainage layers.

This type of surface is very nasty for horses' hooves as it easily cuts the frog. It is also not very nice to walk on.

The sample pictures shown here attempts to show the scale of the problem but the real scale can only be appreciated by a visit. Substantial lengths of the bridleway have been resurfaced in this manner.

In the picture (left) the owner of a house whose garden is on the other side of the path has put down his own fine aggregate to provide a comfortable walking route to his garden.

We have instances where landowners have put down such a surface on a bridleway and Cornwall Council has taken enforcement action to remedy the surface.

The work on this bridleway has been done by Cornwall Council and to date after nearly six months they have done nothing to correct the mistake they have made.

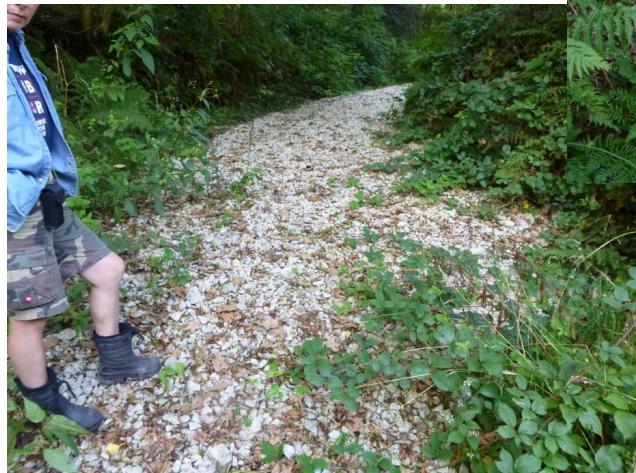
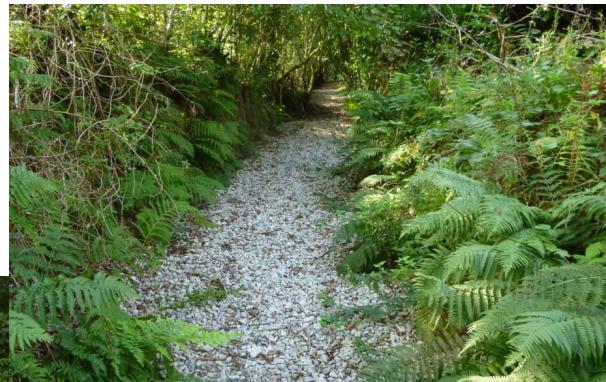
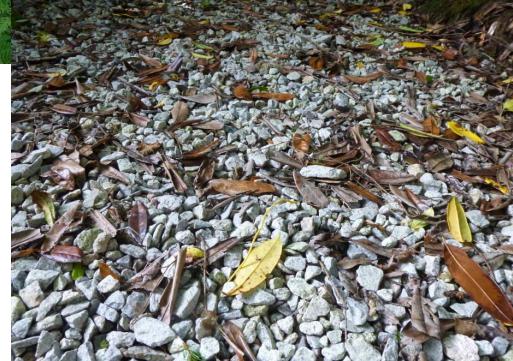
More pictures show other sections of the path and a close up of the large stone aggregate.

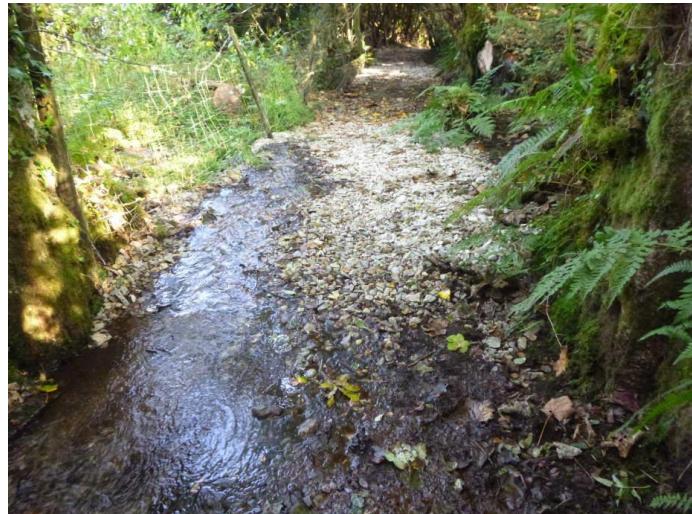
Pictured right is another section of the renovated bridleway where a spring passes over the path before falling off the side. When we visited there had not been rain in the previous few days.

It is surprising that considering the work done on the path that a drainage pipe was not put in to take the water under the path and away. This has been normal practice on similar renovations that have been done in the West of Cornwall.

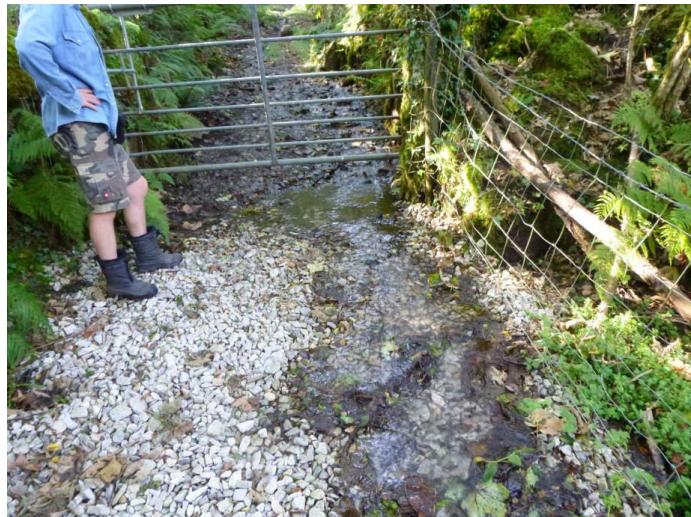
Further up the bridleway we encounter a newly hung gate with newly fitted bridleway handle.

However the gate slams to very quickly with gravity . It is on a narrow section of the track with barbed wire to the right as shown in the picture,

It would be very difficult to negotiate safely either on or off a horse.

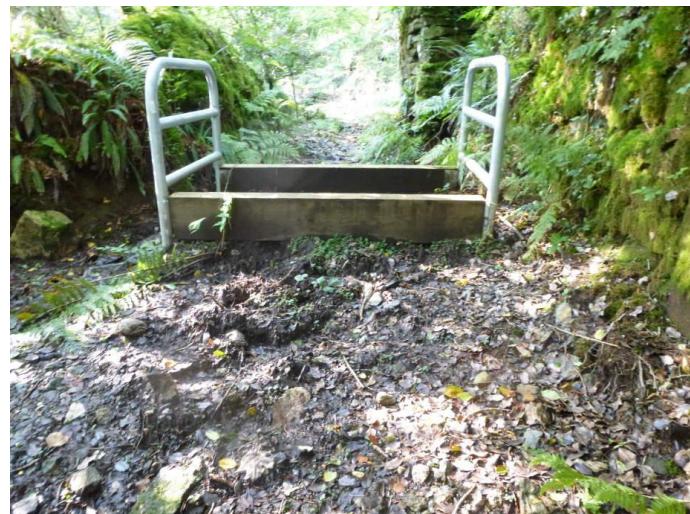
At the top- of an incline we then found a new "Horse Stile" in a sea of deep mud.

The picture here do not show very well just how awful this is.

The intended height of the stile sleepers is greatly increased by the depth of mud and the slope,

It would be unsafe to attempt to negotiate by horse.

The whole installation raises a lot of questions - more pictures follow.

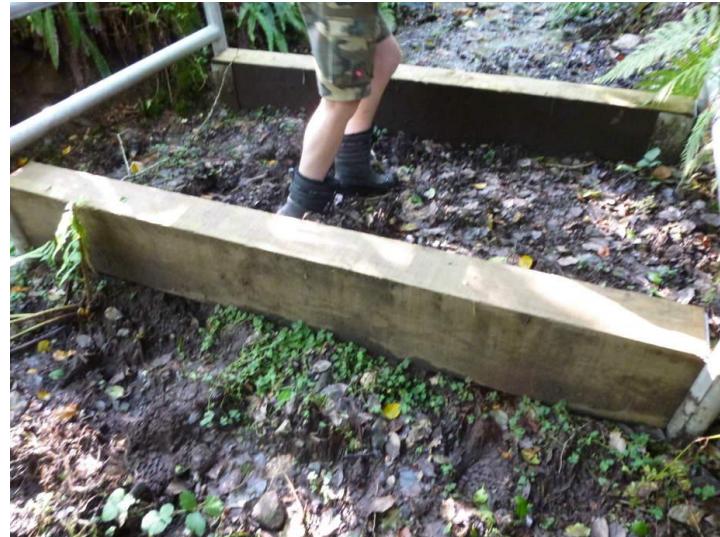
This picture attempts to show how deep and boggy the stile is. Horses are supposed to easily step over the sleepers

The sleepers should be no more than 8 inches deep.

The timbers on this stile are 10 inches deep and with the depth of mud below the effective height is over 16 inches.

This installation is unsafe for horses to use.

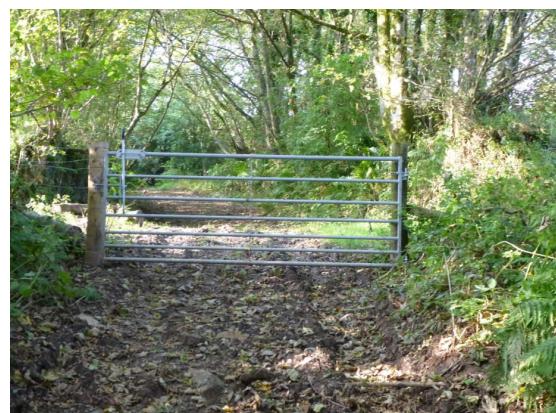
Further up the bridleway a new gate has been installed. Considering it is a new installation the hanging has already dropped and is very difficult to open.

New gate on the approach to Cabilla Manor
